Paragon Polymer Consulting, LLC ♦ csmith@paragonpolymer.com
148 Lugnut Lane, Suite 201, Mooresville, NC 28117 ♦ Phone: (704) 728-5879 ♦ Fax: (704) 663-0073

Report Number 2013115
March 7, 2017

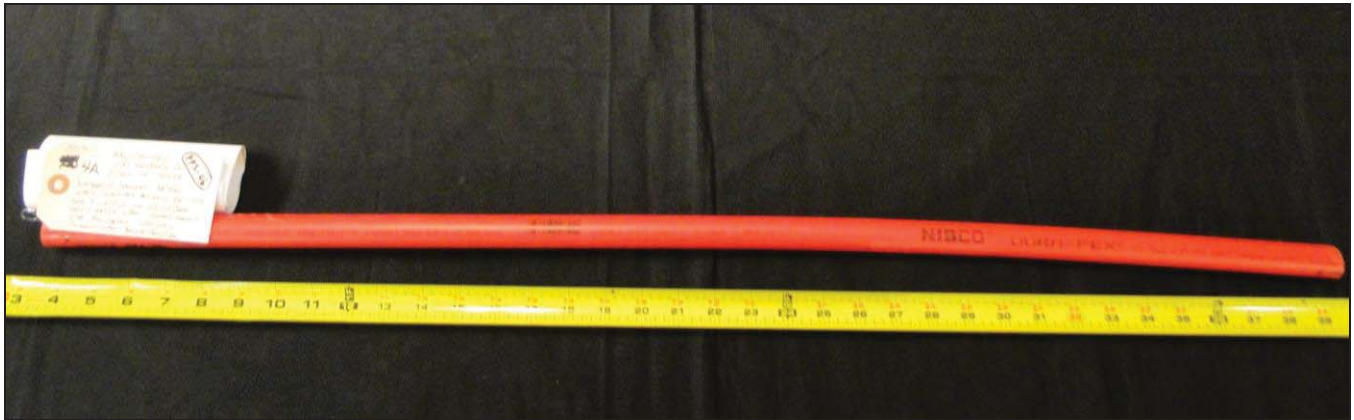
Figure 1: Incident pipe PPX-46 from the Sminkey residence, shown in the as-received condition. (DSC00142)

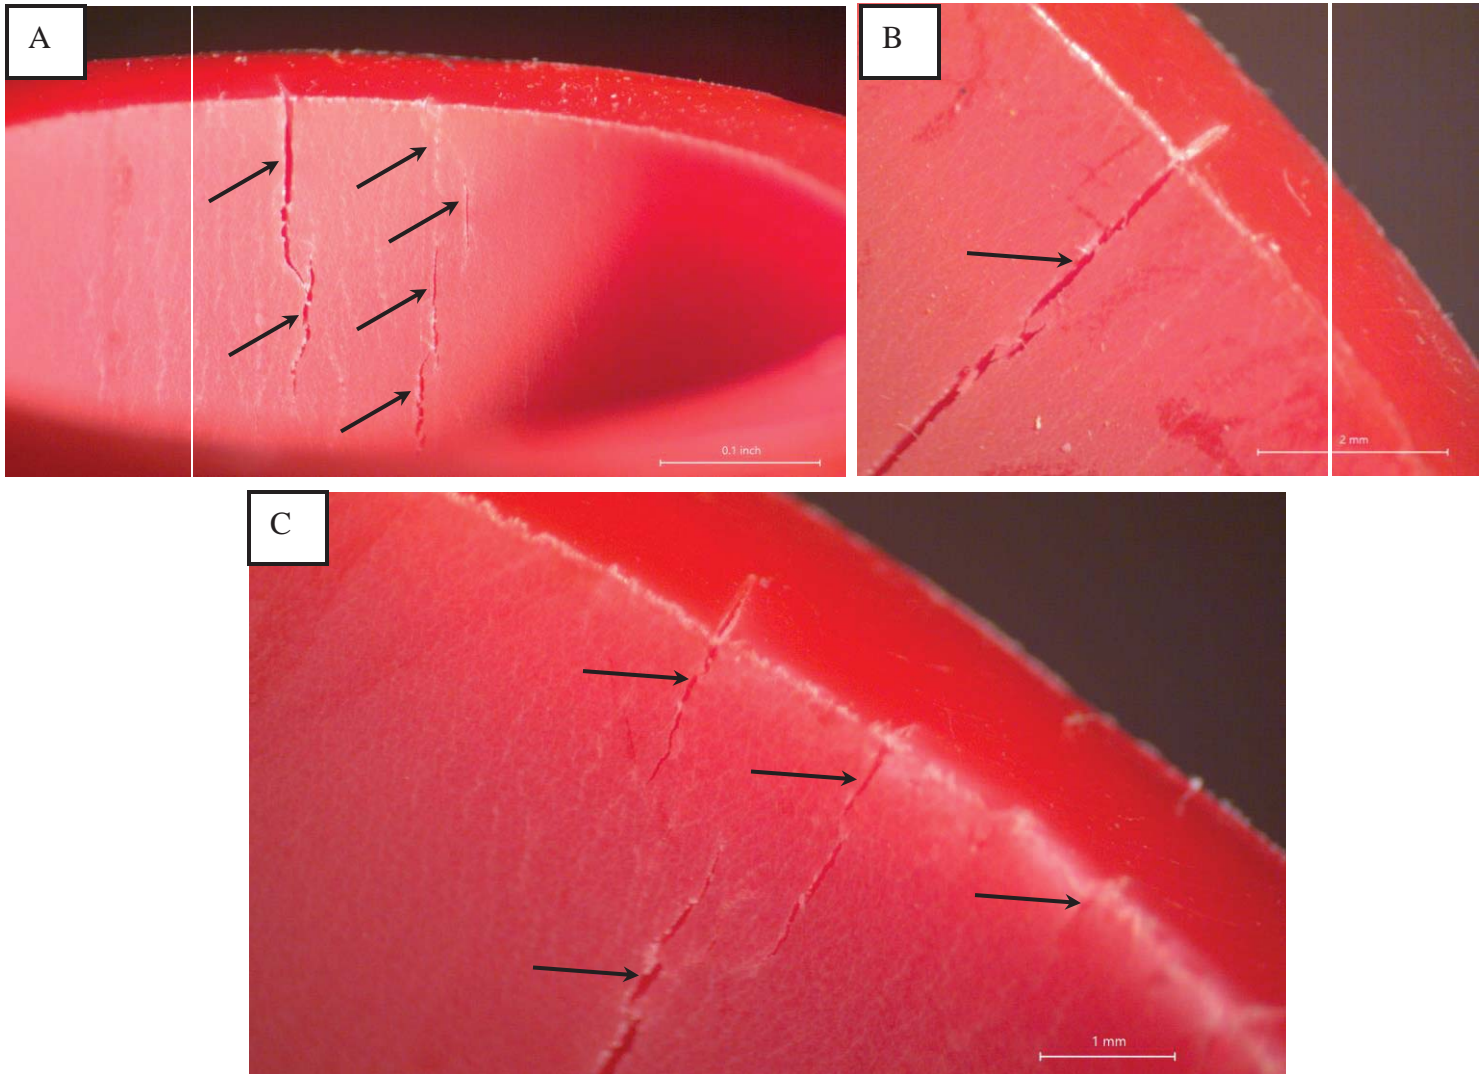
Figure 2: Gaping cracks (arrows) observed at the oxidized interior surface of Sminkey pipe sample PPX-46, shown as viewed using a stereomicroscope.

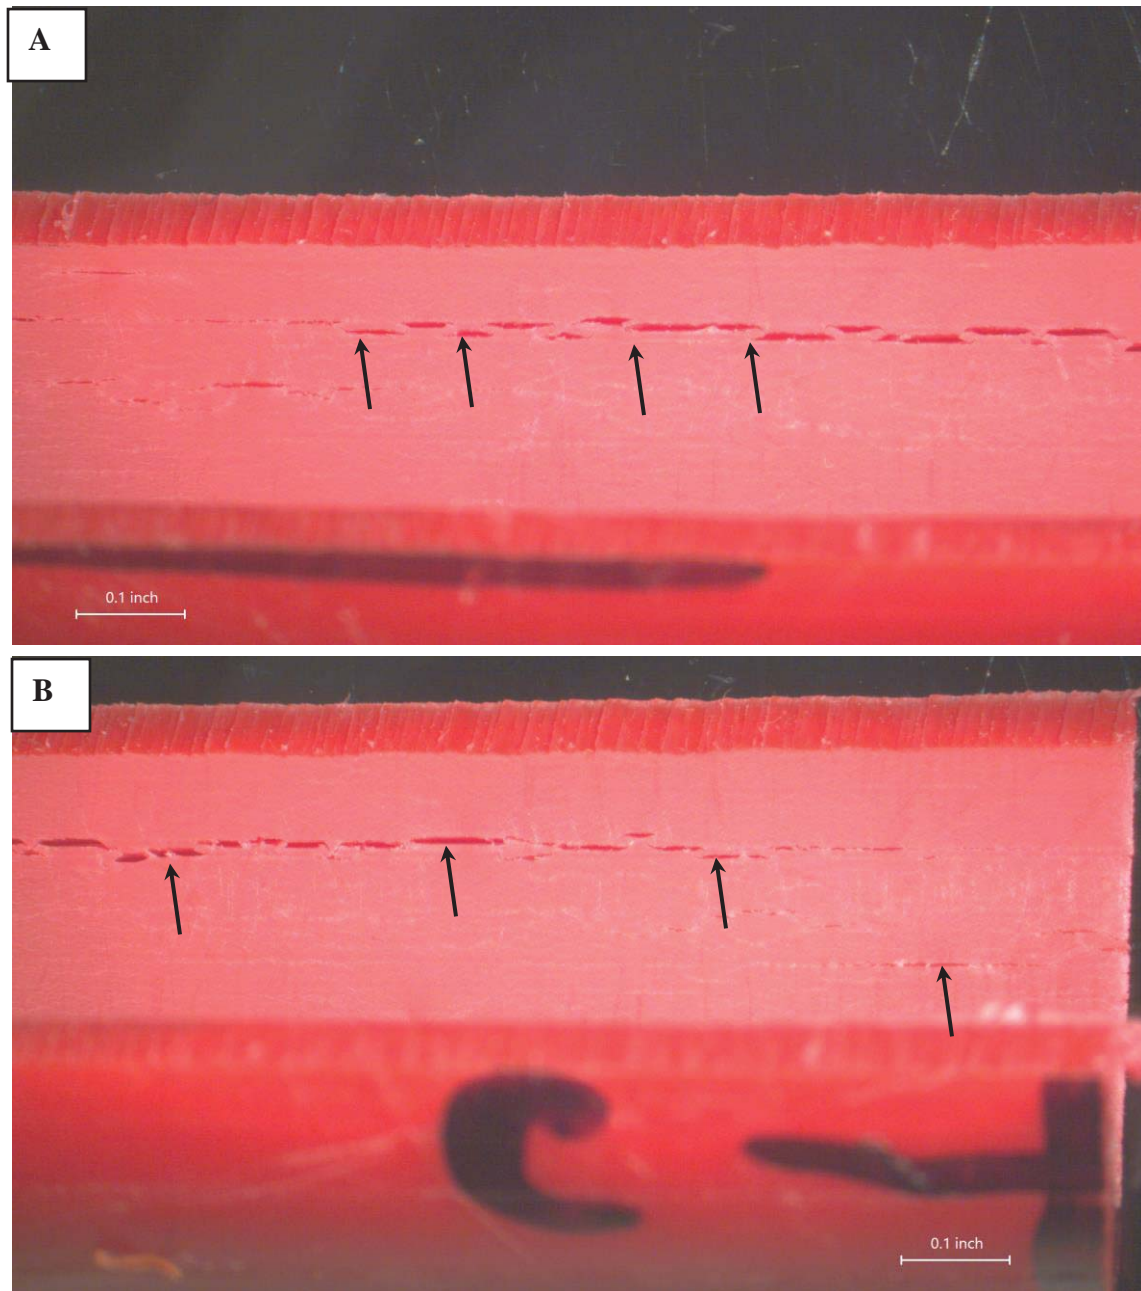
Figure 3: Additional gaping cracks (arrows) visible at the chalky interior surface of Sminkey pipe sample PPX-46, after the pipe was sectioned longitudinally.

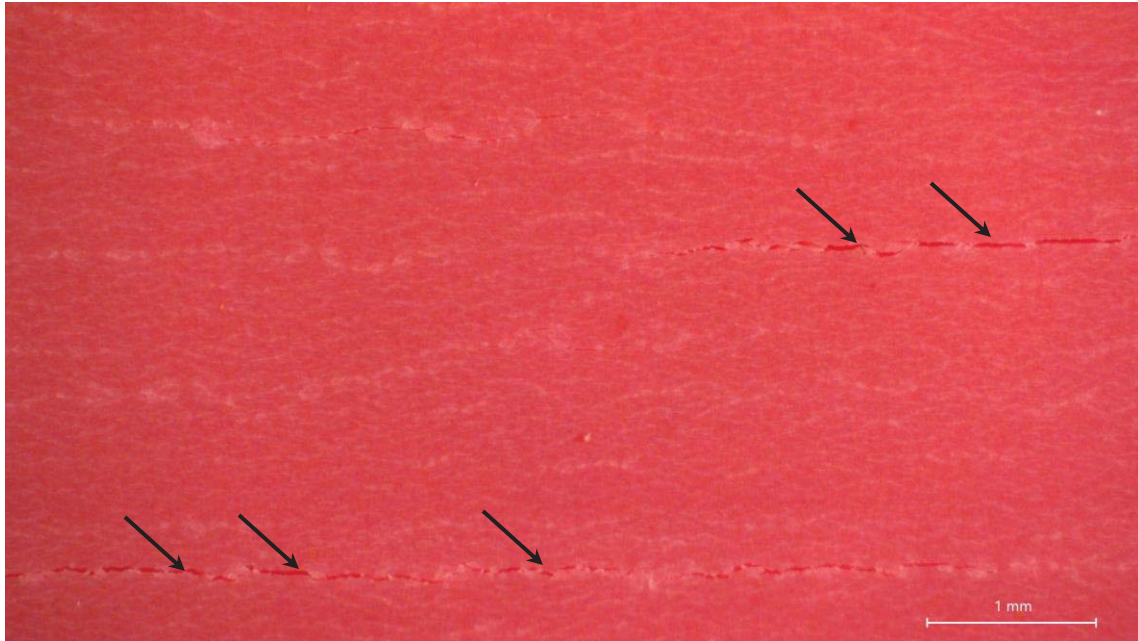
Figure 4: Chalky and crazed interior surface of Sminkey pipe sample PPX-46, shown as viewed using a stereomicroscope. Note that the fine cracks (black arrow) at the interior surface.

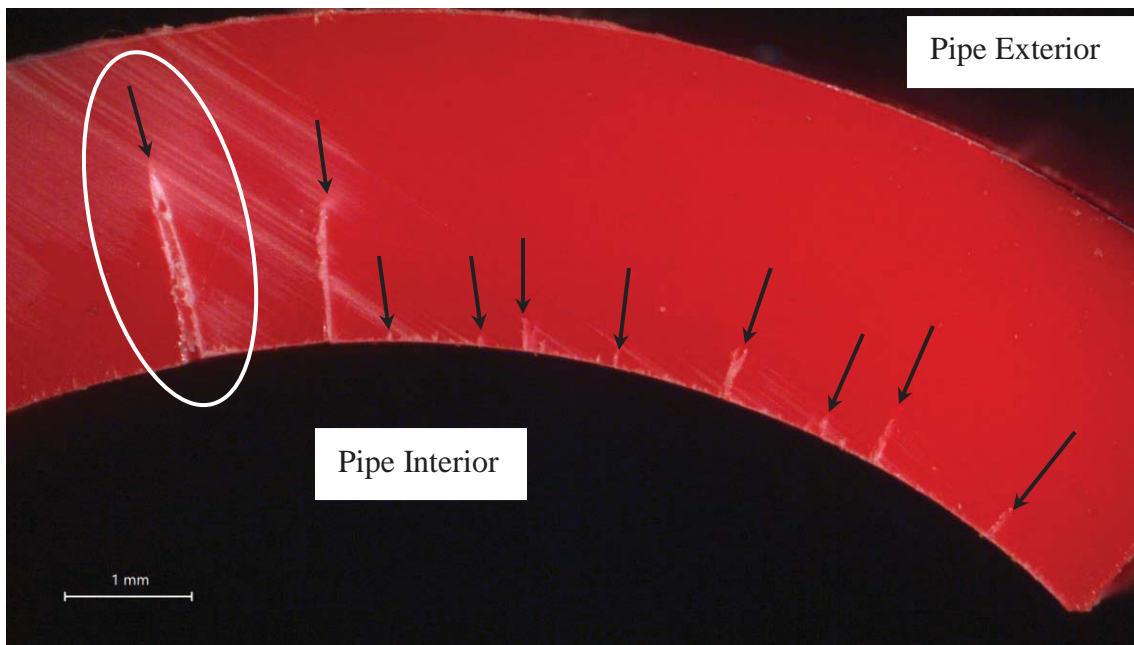
Figure 5: Cross-sectional view of the pipe wall, where approximately 15 partial cracks similar to those identified by arrows could be seen extending 10 to 50% through the wall of the pipe, from the interior surface. The pronounced “v-notch” morphology of the large, encircled crack indicates a high level of residual stress in the polymer material at the interior surface of the pipe. This crack, and other similar cracks, will continue to grow through-wall under hydrostatic pressure.

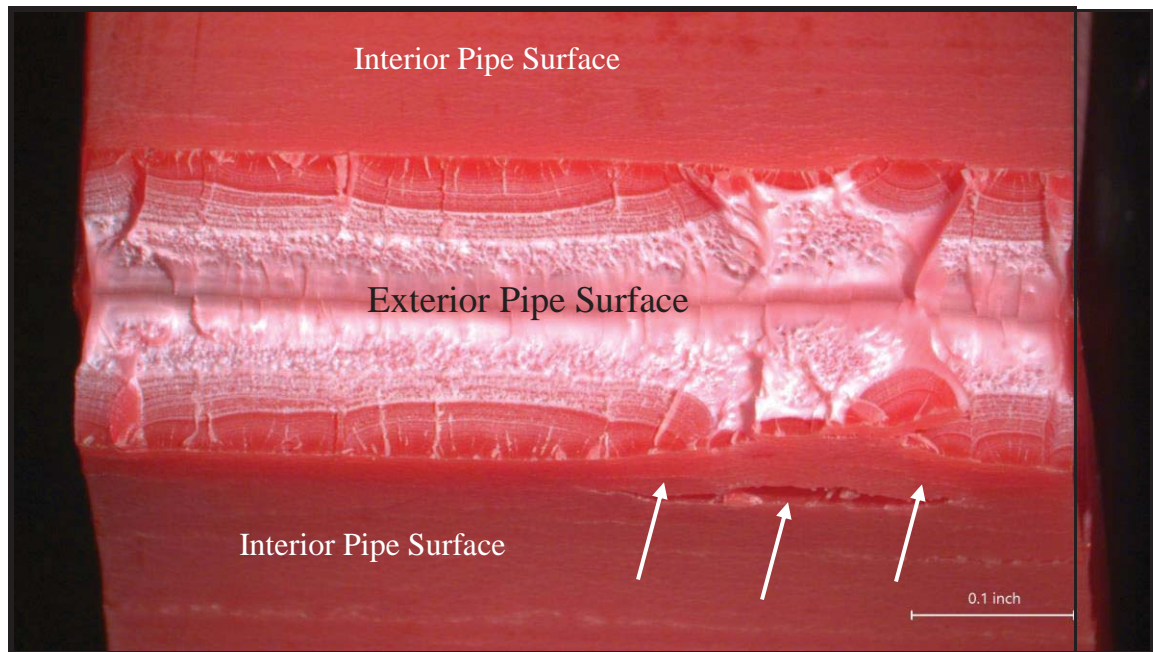
Figure 6: (A) Partial cracks that were mechanically opened to expose the fracture surfaces. These cracks clearly initiated at the interior surface of the pipe and penetrated up to 40% of the pipe wall at this location. Numerous additional crack existed along the full length of Sminkey Sample PPX-46, around the entire pipe circumference.

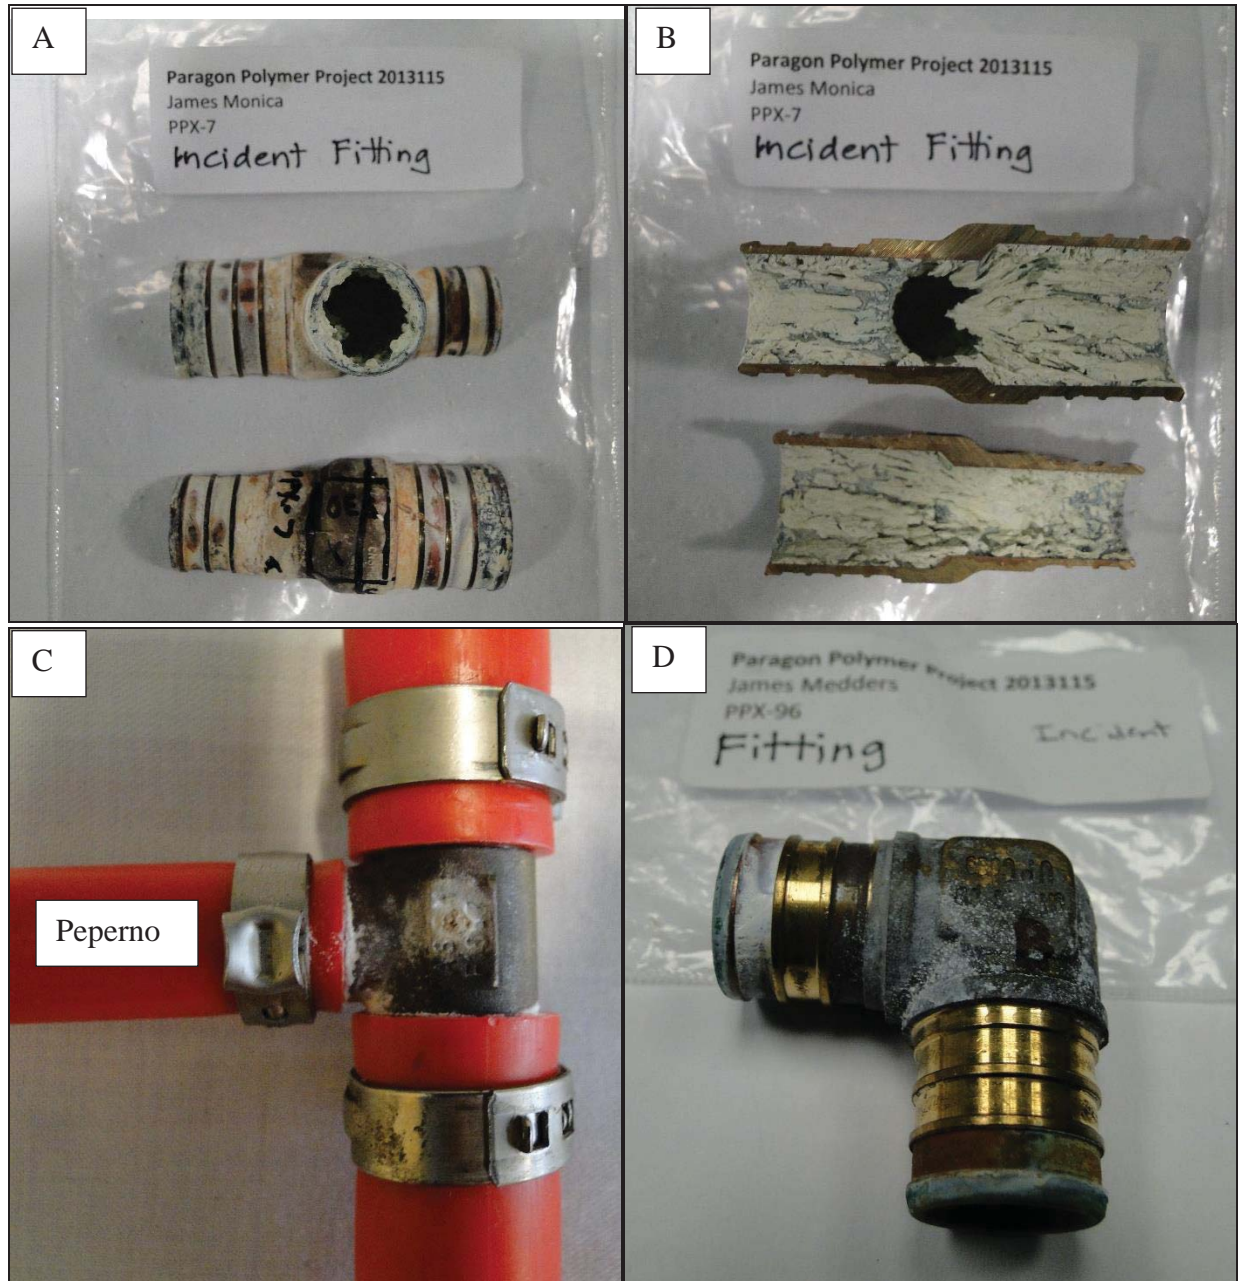
Figure 7: Representative corroded brass fittings from the Cole class action. (A) PPX-7 Fitting Exterior, James Monica; (B) PPX-7 Fitting Interior after sectioning, James Monica; (C) PPX-88, Peperno; (D) PPX-96, James Medders. Although none of the brass fittings from the Meadow case exhibited a similar degree of dezincification, stereomicroscopy revealed evidence of dezincification in nearly every fitting examined. Eventually, the corrosion will penetrate the wall of the fitting, allowing water to weep through.

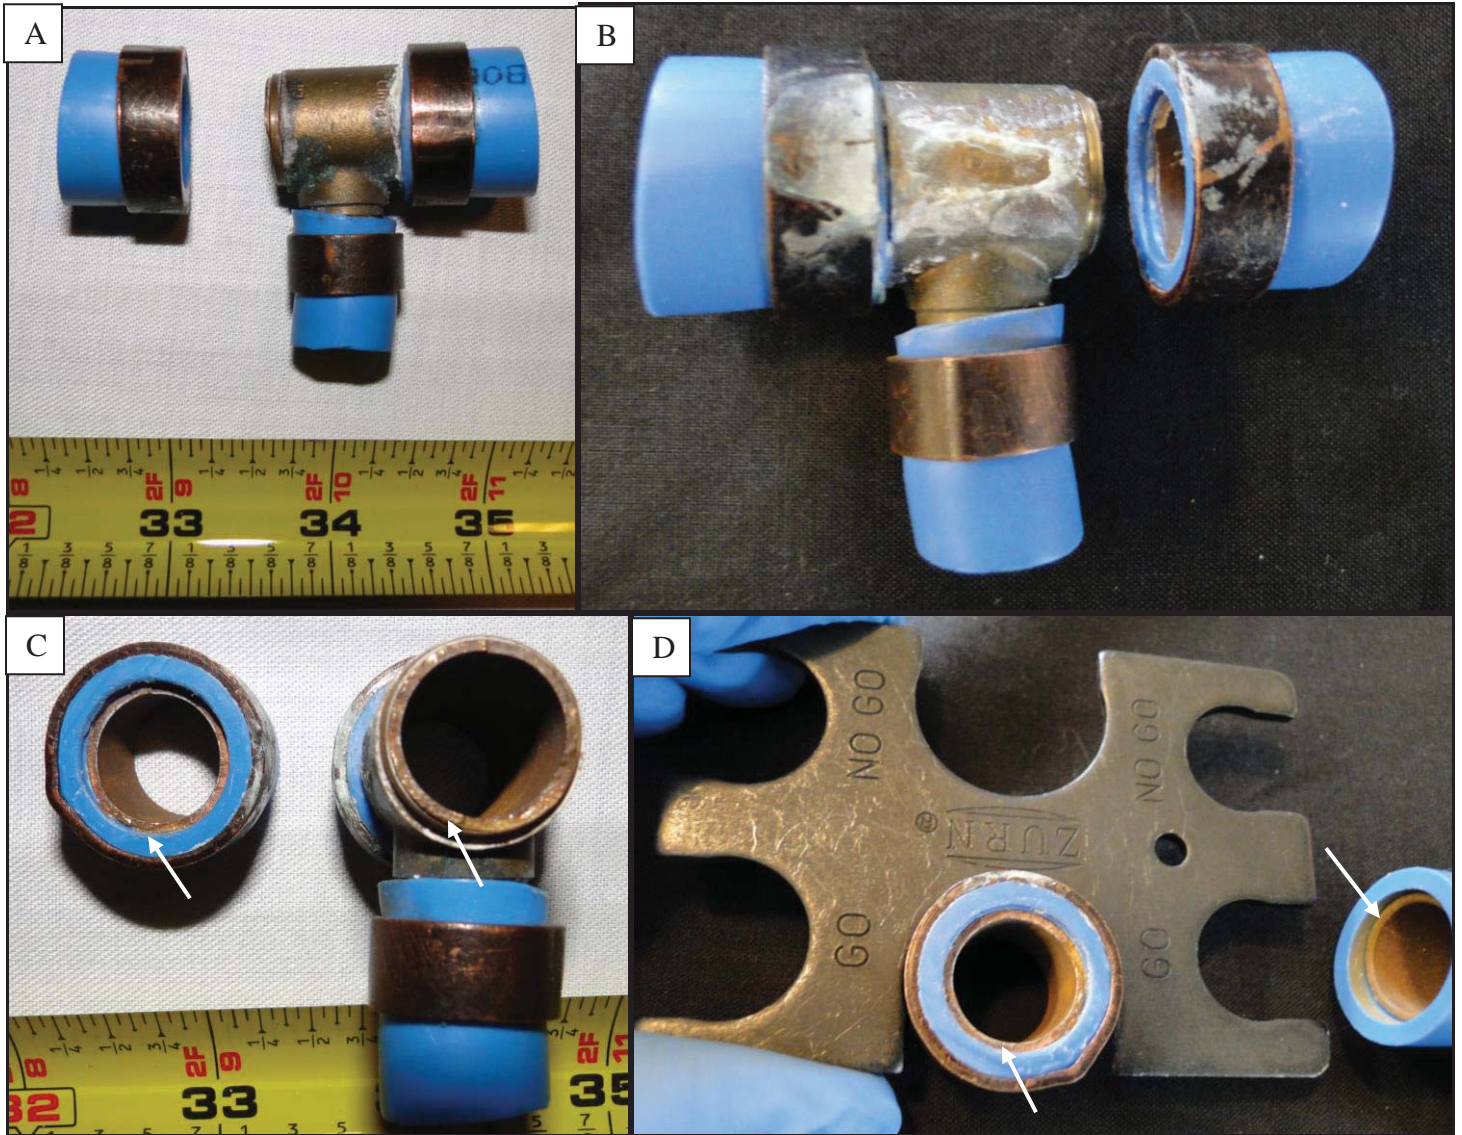
Figure 8: (A, B) Front and back views of an incident fractured brass fitting from the Medders residence (Medders Sample PPX-99), shown in the as-received condition. One outlet from this fitting had completely fractured away from the rest of the fitting during service, resulting in an appreciable loss of water. (C) Separation fractures (arrows) from the incident brass fitting, and (D) PEX Go-no-go gauge demonstrating that the copper crimp ring was properly crimped. This fracture was found to have resulted from the combined effects of transgranular stress corrosion cracking and dezincification corrosion.

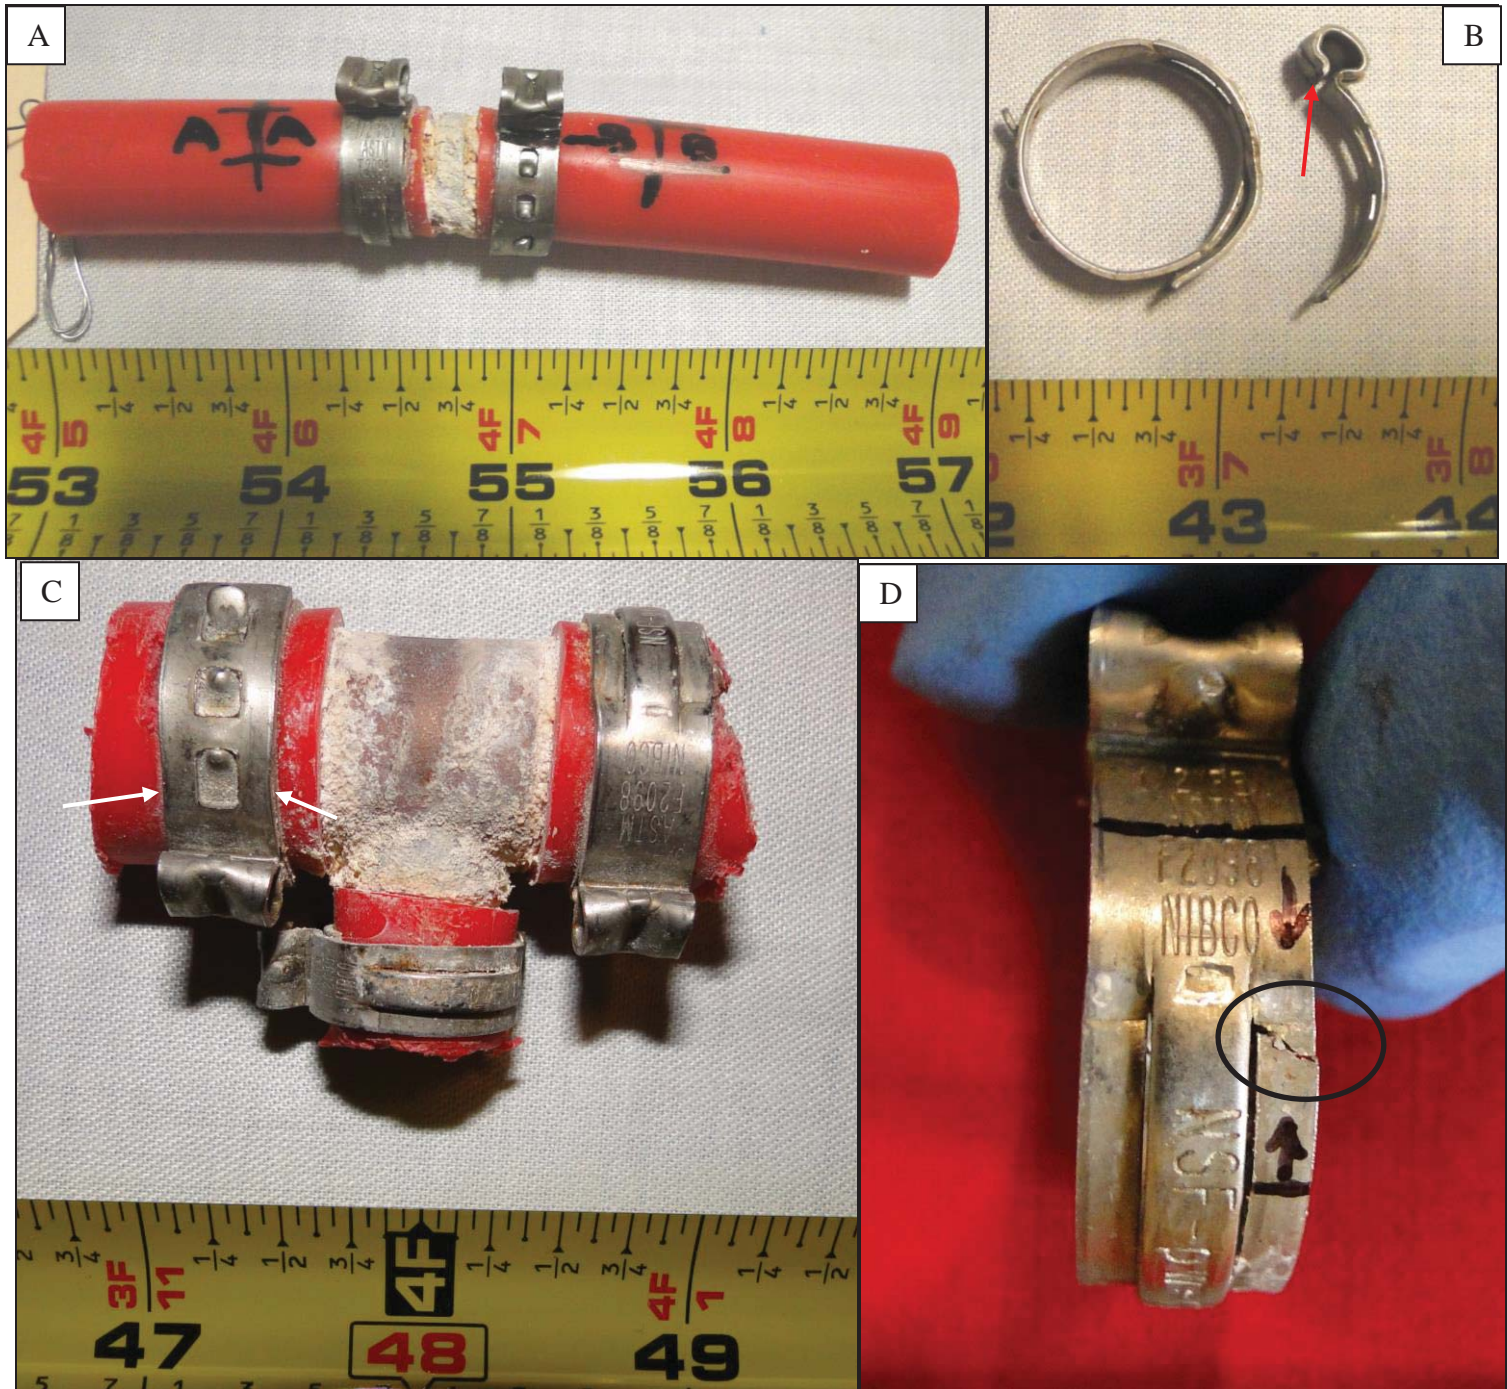
Figure 10: (A) Monica Sample PPX-8, showing dezincification of a brass coupling with adjacent cracked stainless steel PEX clamps. (B) Cracked clamp from Monica PPX 11. This clamp fractured at the ear (arrows) due to chloride-induced stress corrosion cracking. (C) Monica Sample PPX-9, showing a corroded brass fitting and adjacent stainless steel clamps with signs of stress corrosion cracking (brown deposits at arrows). When a brass fitting corrodes in this manner, chloride-rich water can seep through the wall of the fitting, wetting the adjacent stainless steel clamps with incompatible chlorides. The “necking” (narrowing) visible at the white arrows indicated that the clamp was in a highly-stressed state. (D) Cracked clamp (crack is encircled) from Monica PPX-8 (reference View A).

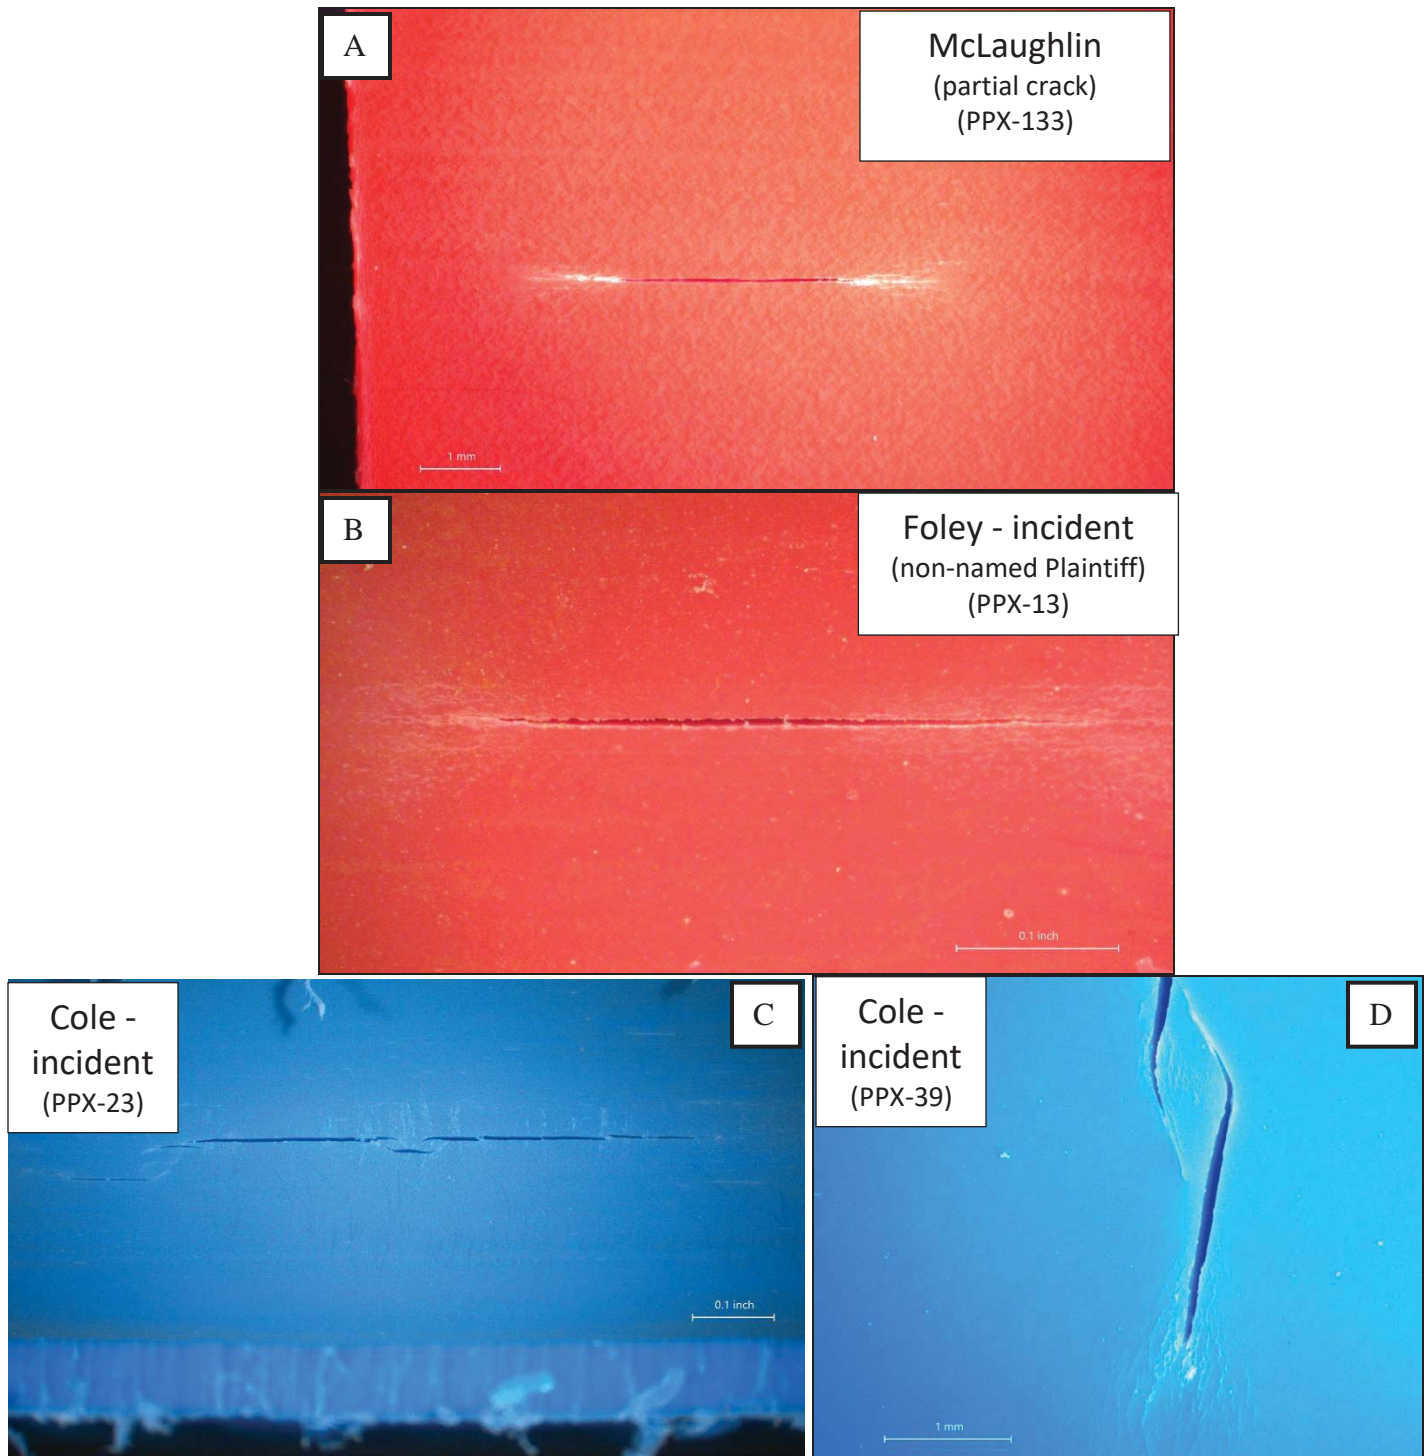
Figure 11: Representative brittle cracks as seen at the interior surface of the pipe, using a stereomicroscope: (A) the McLaughlin residence (Sample PPX-133, longitudinal partial crack that had not yet propagated entirely through-wall), (B) the Foley residence, a non-named class member (Sample PPX-13, longitudinal incident crack), (C) the Cole residence (Sample PPX-23, longitudinal incident crack), and (D) the Cole residence (Sample PPX039, circumferential incident crack).

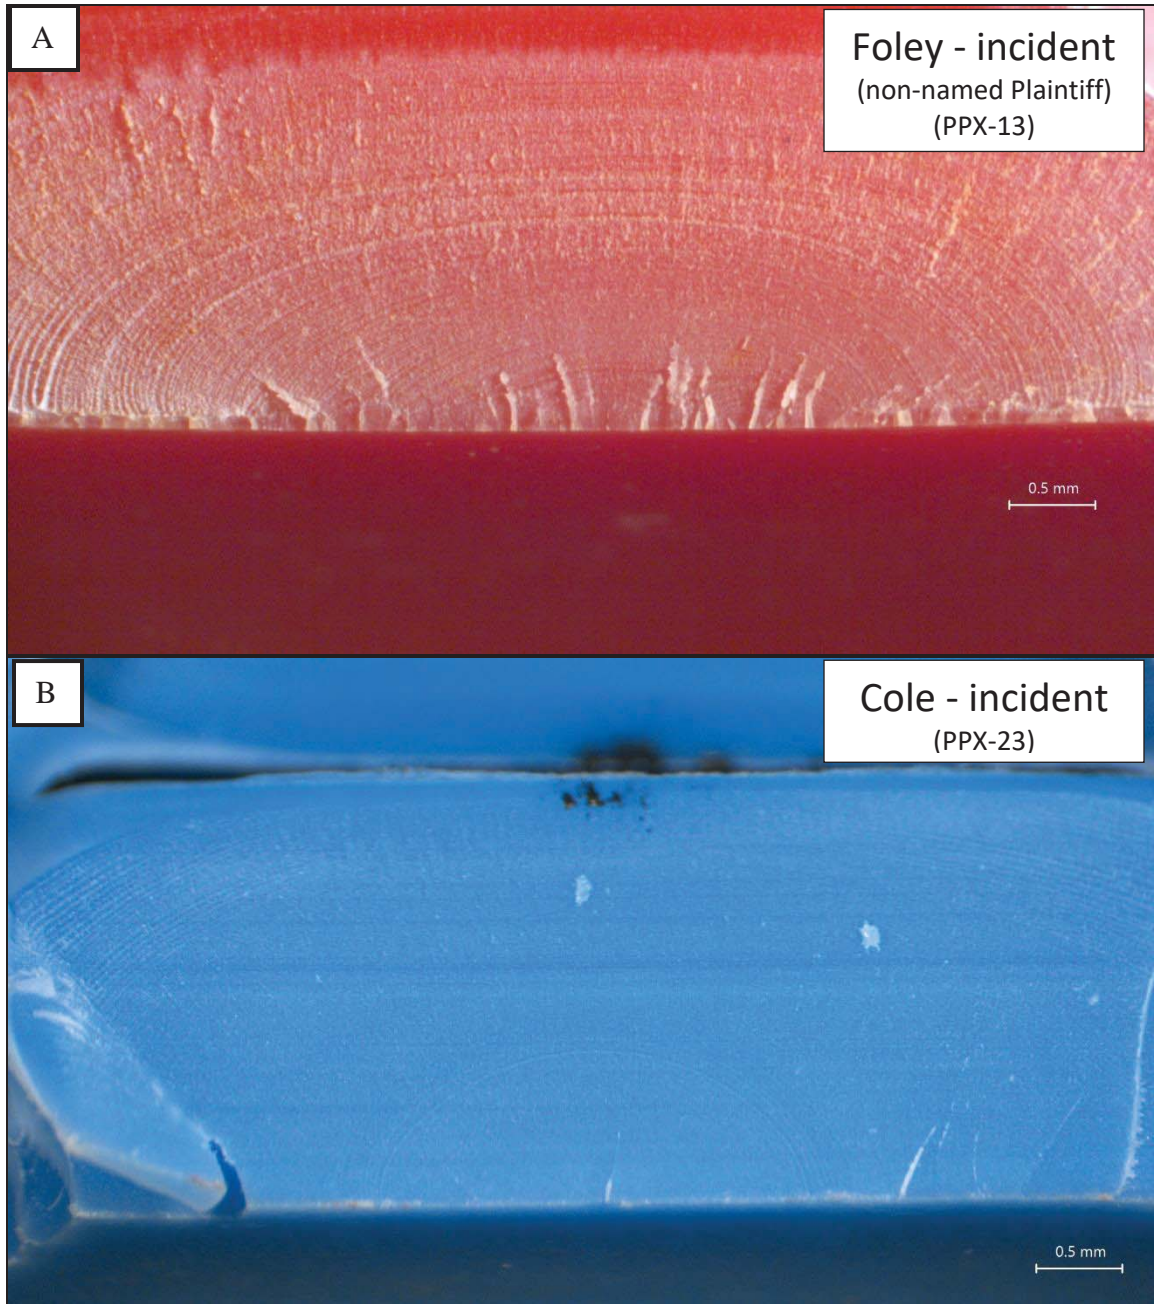
Figure 12: Stereomicroscope images of exposed fracture surfaces from the incident cracks in (A) Foley Sample PPX-13 and (B) Cole Sample PPX-23 (reference Figure 11). Most fractures initiated at multiple locations at the interior surface of the pipe, and multiple crack fronts merged to form a larger continuous crack, unless an inclusion existed at the fracture origin. No stress whitening, yielding, or appreciable ductility was observed at either crack or fracture. Extensive crazing was noted at the interior surface of each pipe. These fractures initiated due to brittle oxidative degradation, and propagated by creep rupture. Little or no evidence of ductility was observed at the interior surface of the pipe, adjacent to either fracture.

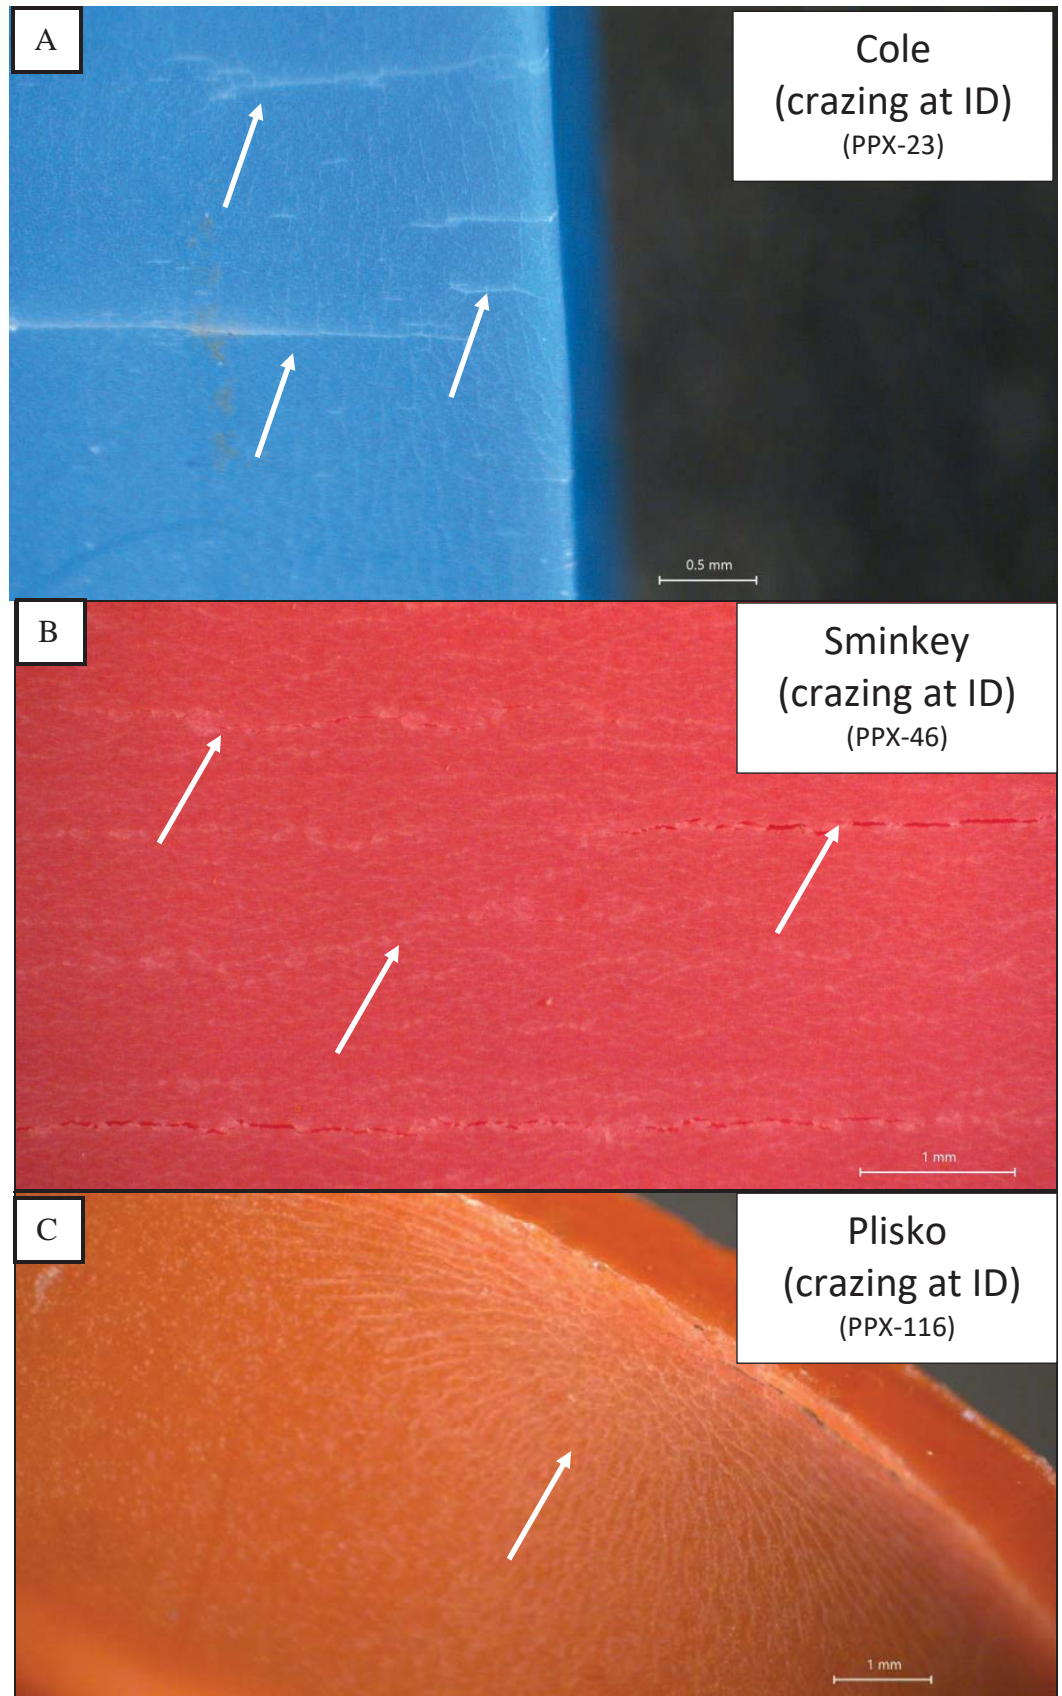
Report #2013115 - Analysis of NIBCO PEX Plumbing Components

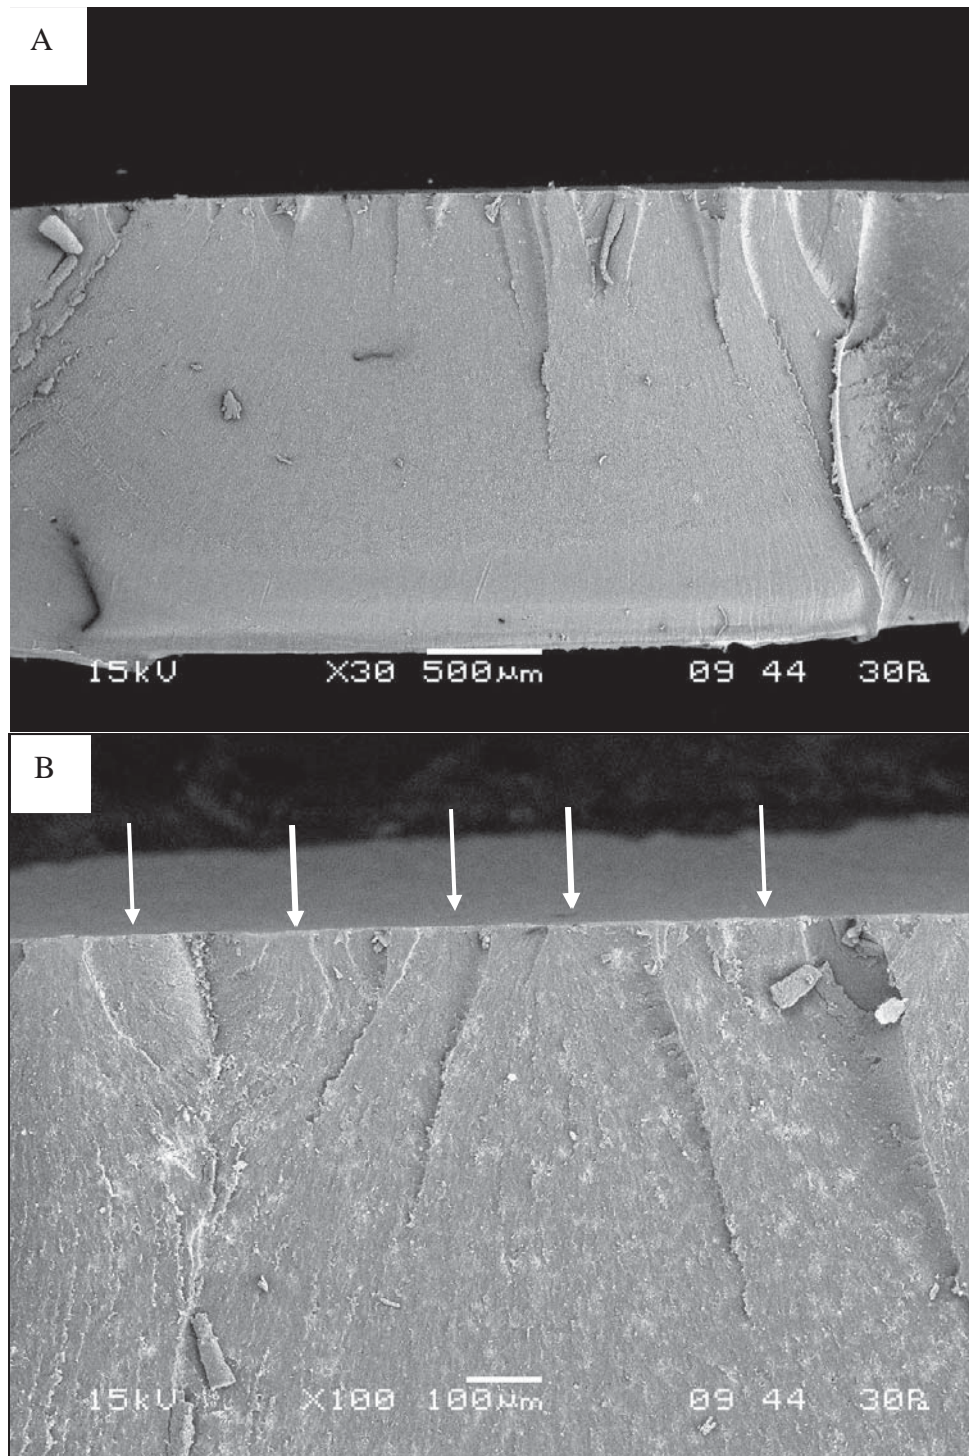
Figure 14: (A) Exposed fracture surface from McCoy Sample PPX-31, shown as viewed using a scanning electron microscope in the back-scattered electron imaging mode. This fracture initiated at the interior surface of the sample, at multiple locations as indicated by arrows in View (an adjacent region of fracture not depicted in View A).

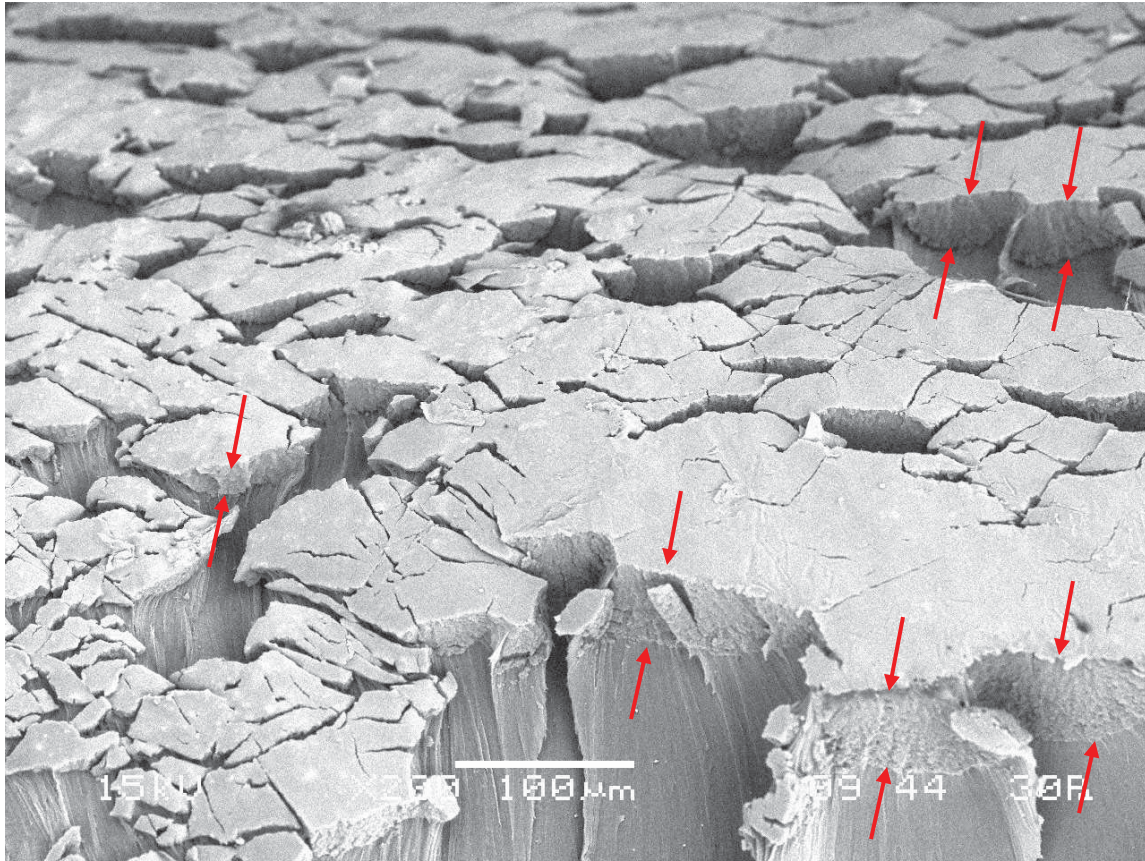
Figure 15: (A) Interior surface of McCoy Sample PPX-31, adjacent to the exposed fracture surface, where numerous craze cracks were revealed during bending to expose the fracture surfaces. This was essentially a modified bend-back test. These cracks clearly exhibited discernible depth as indicated by arrows.

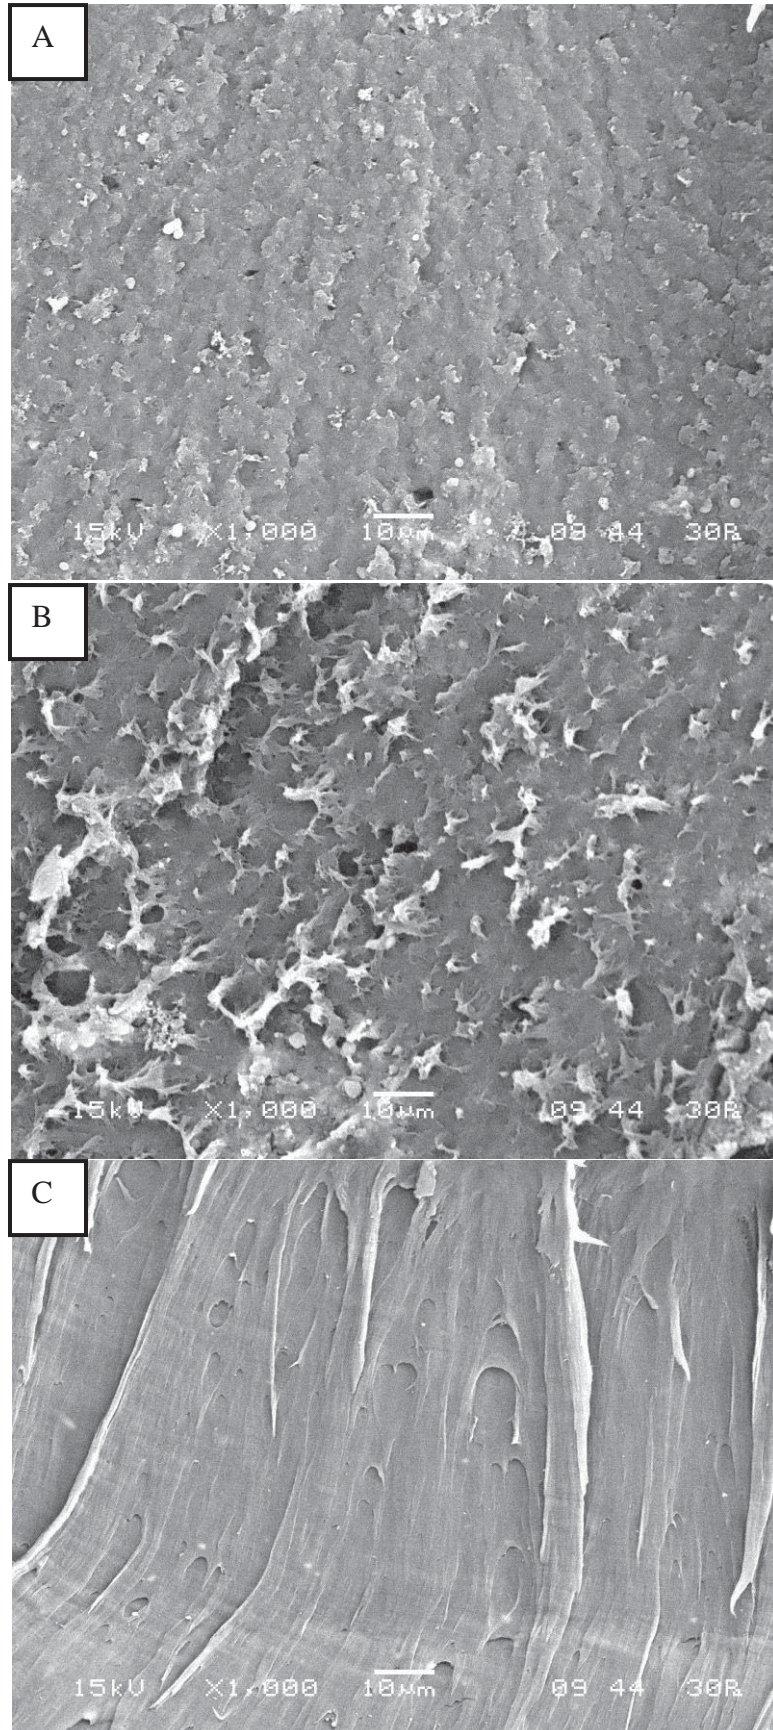
Report #2013115 - Analysis of NIBCO PEX Plumbing Components

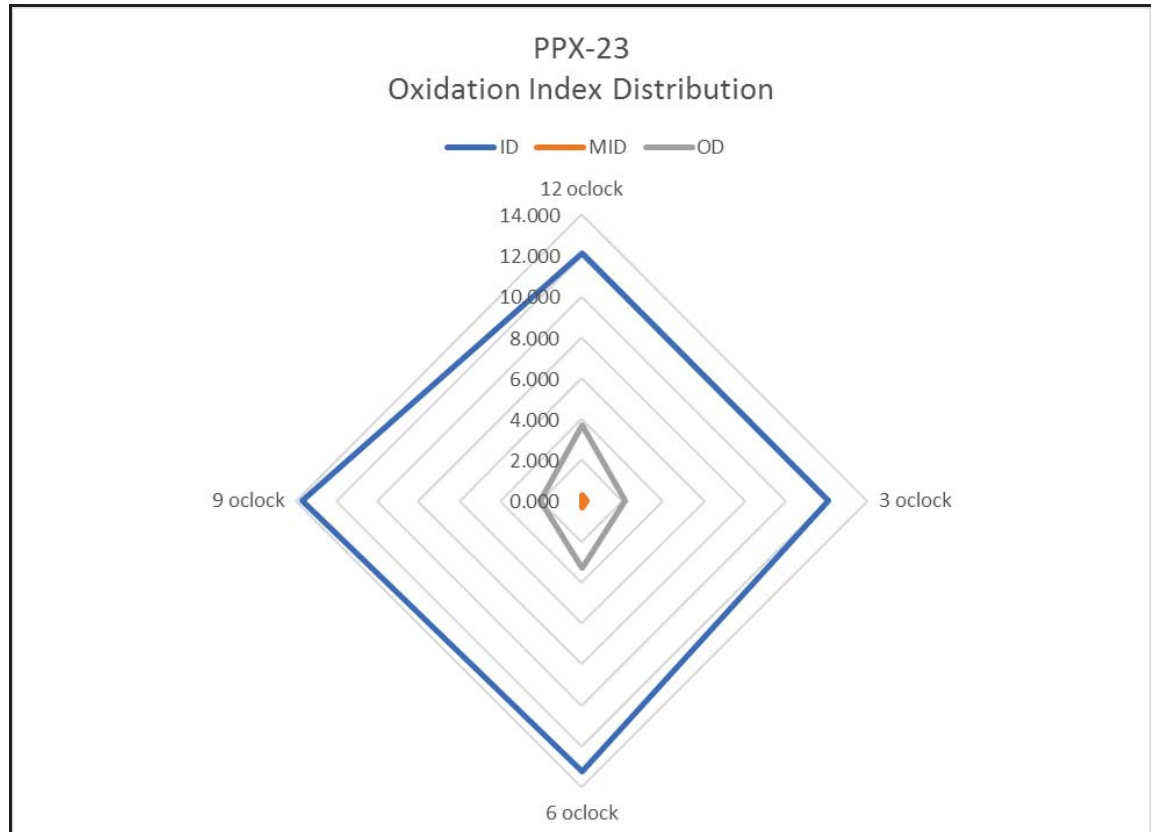
Figure 18: FTIR radar graph showing the oxidation index as a function of location within the pipe wall and around the pipe circumference for Cole Sample PPX-23. This sample showed significantly more oxidation at the interior surface than elsewhere in the pipe wall, around the entire pipe circumference. No evidence of UV damage was detected.
